安全、綠化、悅目的中大斜坡

Safe, Green and Beautiful – Slopes of the Chinese University

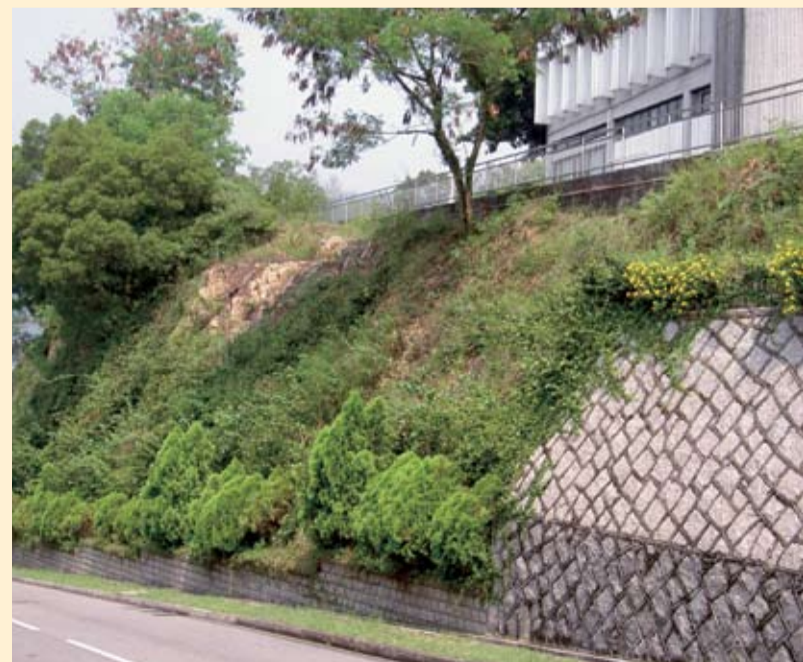
往聯合書院沿路的一道石面斜坡，現在長滿了綠葉
A rock surface slope on the road to United College now teems with green

Examples include the planting of ornamental shrubs and climbers on slopes and retaining walls, the use of earth-toned masonry facing, and adoption of advanced greening technologies such as mulching.

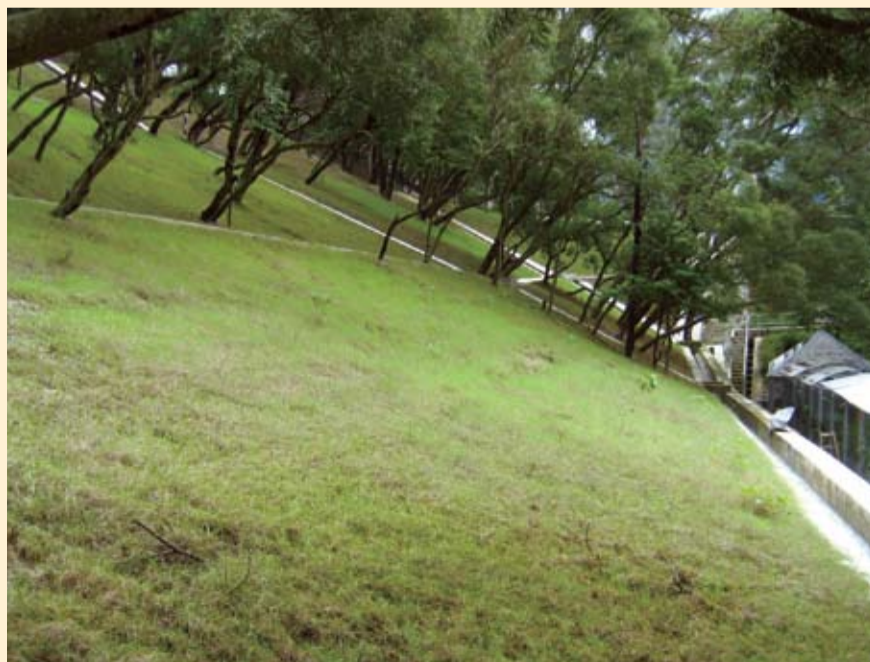
在邵逸夫人樓附近的回填坡，是藉挖坑種植來鞏固的。這種方法可盡量減少移植樹木，部分過程須用人手處理，耗時較長。
A more time-consuming method of stabilization—trench excavation—was used to stabilize this fill-slope near the Lady Shaw Building so tree removal can be minimized. Part of the procedure was carried out manually.

Contrary to common belief, trees do not necessarily have to be removed during slope improvement works. At the University campus, for instance, soil nailing is used to stabilize cut-slopes in order to reduce disturbance to trees, and where the slope surface has to be regraded, tree rings and toe walls are sometimes used to retain trees. Sometimes trench excavation, a more time-consuming and partially manual method of

stabilization is used to stabilize loose fill-slopes in order to minimize the need for tree removal.

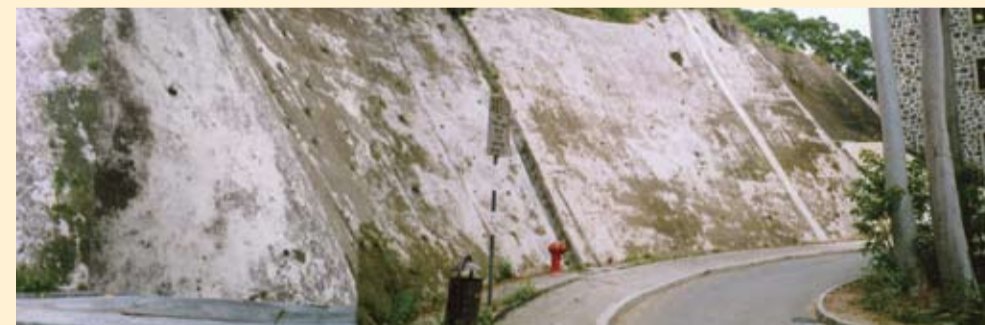
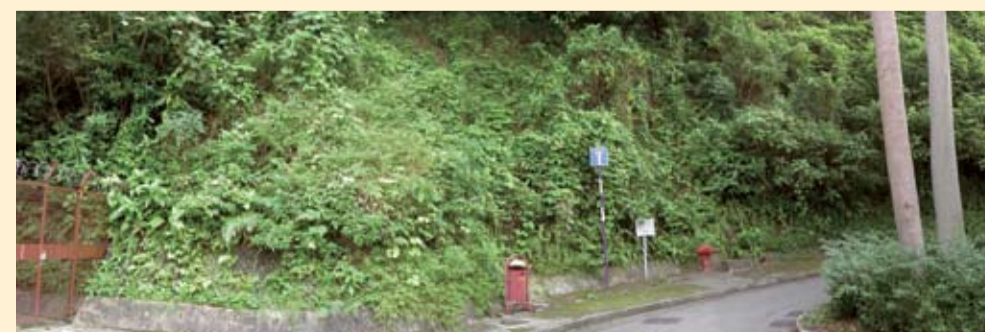
九十年代在崇基職員宿舍附近蓋滿灰泥護面的斜坡（上圖）；同一斜坡的現貌（下圖）。
Before: a slope covered with chunam plaster near Chung Chi staff quarters in the 1990s (top)
After: the same slope now (above)

slopes include slopes sprayed with concrete, rock outcrops and retaining structures. In the 90s, shotcreting (projecting concrete through a hose onto a surface) was the dominant method of surface protection after slope stabilization in Hong Kong. Quick, cheap and effective, it was widely used by the Government. But the shotcrete nozzle is a Vesuvius that mummifies everything within its radius with a layer of white lava. Shotcreted hillsides look lifeless and incoherent. So while the technique was still used to treat dangerous slopes and as an emergency measure, the University shifted its focus to methods that would bring more aesthetically pleasing results.
